# Robot performs in-service tank inspection – keeps railroad’s locomotives on time.

TANK CONSTRUCTION	
Year built	1979, re-erect
Tank Diameter	114.5 feet
Tank Height	35 feet
Capacity	2.7 million gallons
Foundation Type	Earthen
Bottom Type	Lap-welded Double Bottom
Product	Diesel, red-dyed

In May 2022, Square Robot, Incorporated performed a Phased Array Ultrasonic Thickness (PAUT) Robotic Internal Inspection and API 653 External Inspection of Diesel Tank HVN T-105 for The Kansas City Southern Railway Company (KCSR) at their Heavener, Oklahoma fueling facility. The results of this inspection were used to provide an evaluation per the applicable criteria of API Standard 653, Tank Inspection, Repair, Alteration, and Reconstruction, 5th Edition, November 2014, Addendum 1 (April 2018), and Addendum (May 2020).

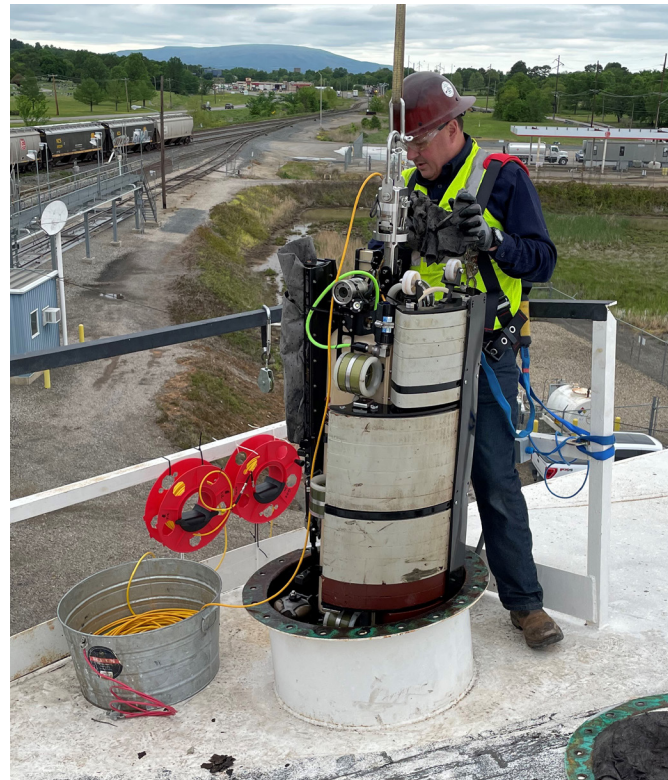
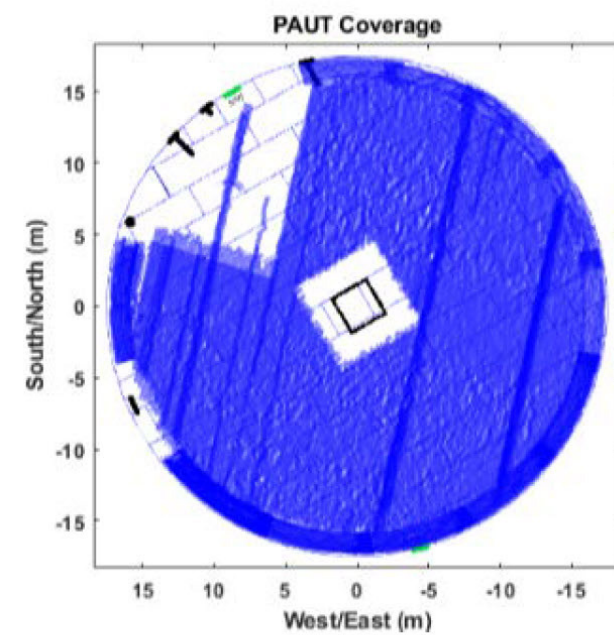
The robot successfully inspected 81% of the tank bottom and 95% of the accessible inspection area. PAUT data revealed two areas of remaining thickness at or below 0.202-inch (19% wall loss) on the bottom plates. This corrosion was determined to be on the soil side of the bottom plates. The lowest remaining thickness of the area is 0.174-inch (32.6% wall loss). Based on this remaining thickness, the recommended next internal inspection will be in 17.8 years.

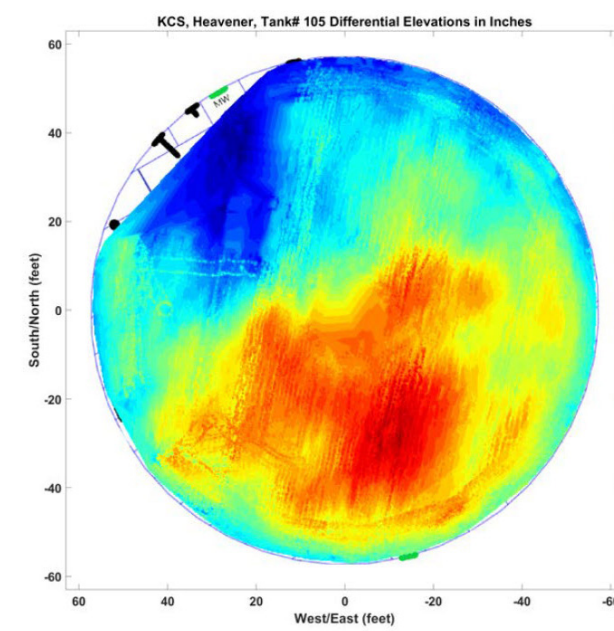
Figure 4 - Contour Plot of Differential Elevation (in)

A double bottom was discovered during the external inspection by Square Robot crew chief, Billy Yackel. The double-bottom interstitial space was identified as being filled with sand and cathodic protection anodes with the dead shell between the two bottoms stitch-welded containing 2-inch gaps. The foundation was found to be in acceptable condition. The tank edge settlement was measured and determined to be within tolerances.
