Maximizing Data Quality for In-Service Tank Inspections – Calibrations to Confirmations

SR-3
Autonomous
Submersible
Tank Inspection Robot

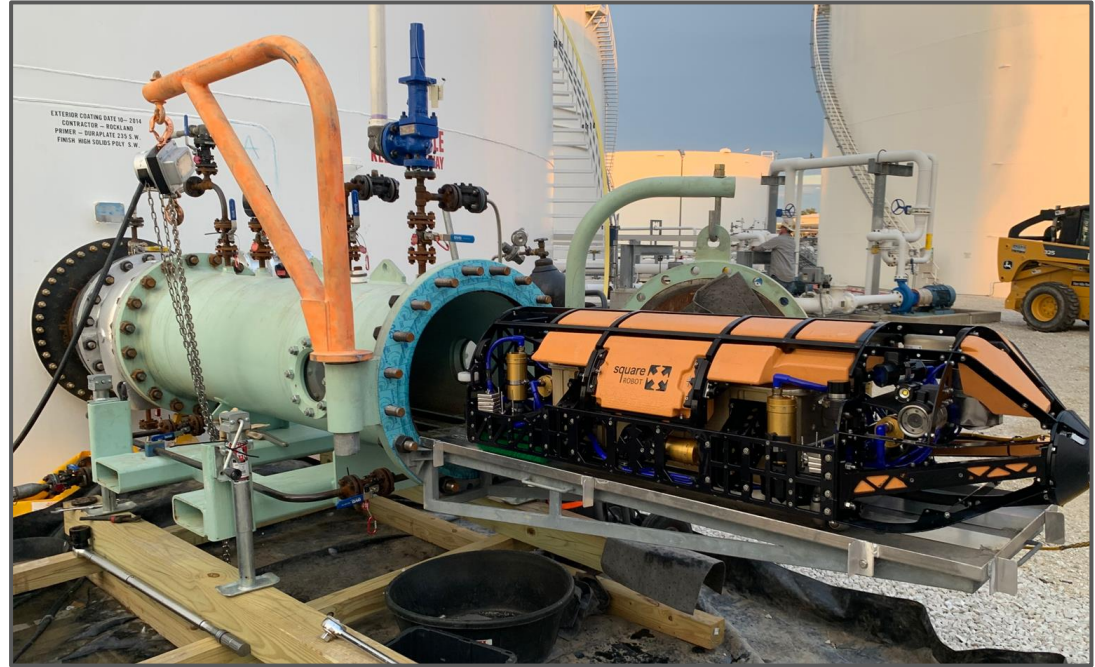
SR-3 Robot Side Launcher System

Vehicle Chamber **24" Gate Valve** **Manway Adapter**

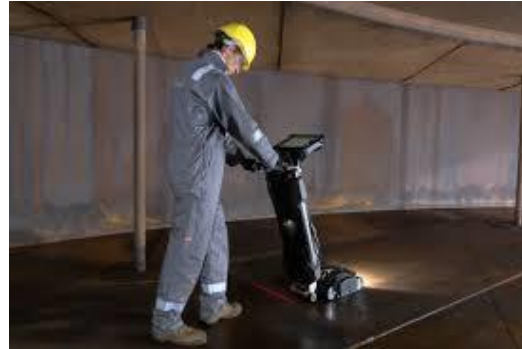
OUT-OF-SERVICE
MFL SCANNING

Magnetic
Flux Leakage

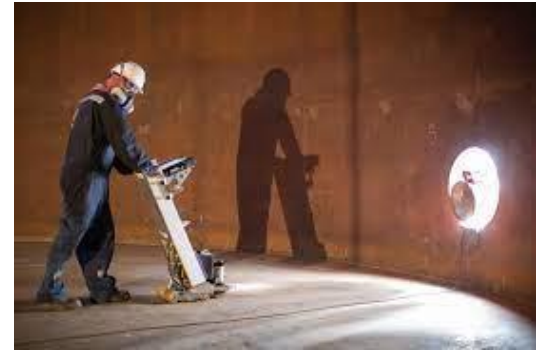
OUT-OF-SERVICE
SLOWFEC SCANNING

Saturated Low
Frequency
Eddy Current
