Internal Robotic API 653 Tank Inspections and Capabilities for Midstream Facilities

Midstream Market - How Square Adds Value

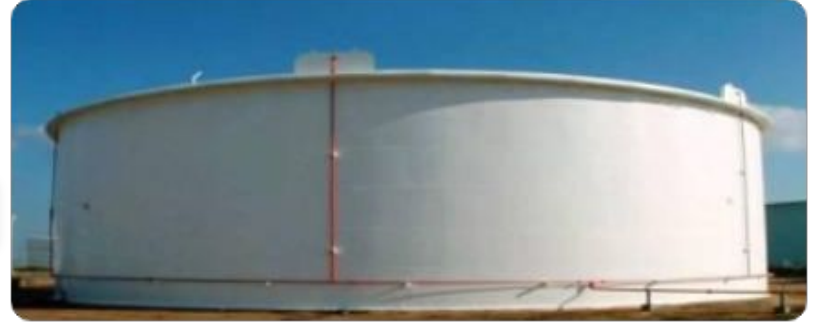
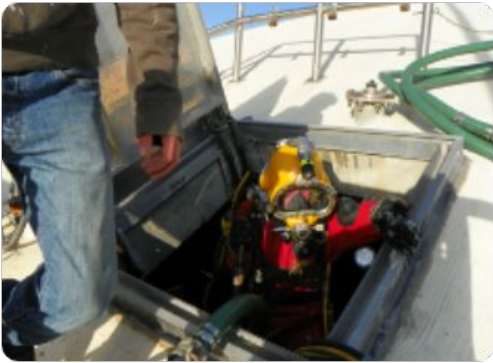
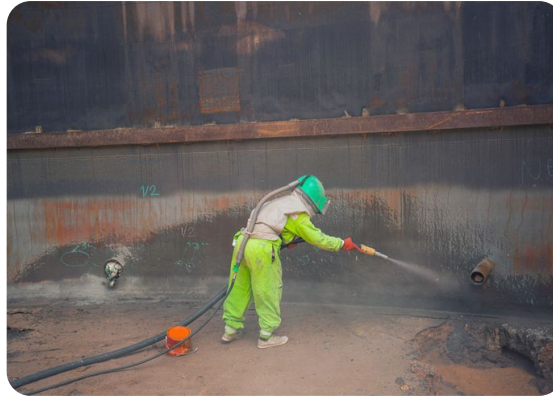
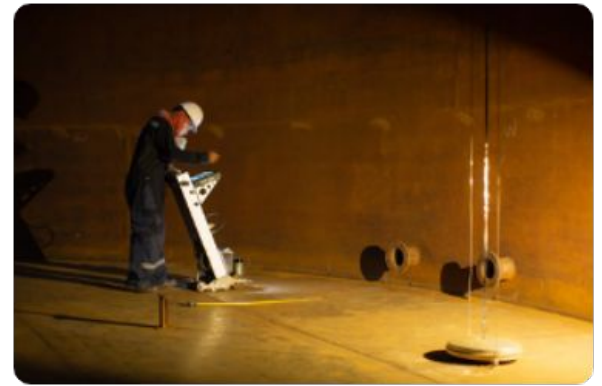
Tank Inspection - The Traditional Approach

- ❑ PROJECT LASTS WEEKS OR MONTHS
- ❑ DRAIN, VENT, CLEAN, WASTE DISPOSAL
- ❑ INSPECT WITH MFL or SLOFEC
- ❑ VALIDATE WITH SPOT ULTRASONIC (UT)

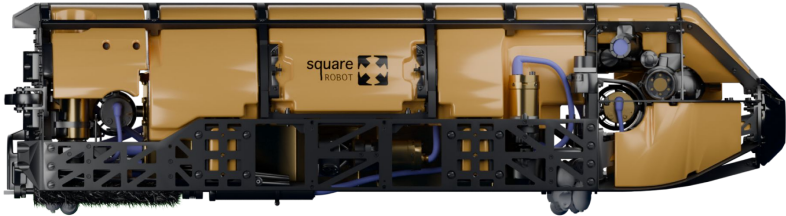
SR-3 Autonomous Submersible Tank Inspection Robot

Launch/Recovery Method

Communications

Tank Type

Product Compatibility

PAUT Bottom/Coating Thickness

Bottom Settlement Under Load

Visuals of Bottom, Shell, Internals

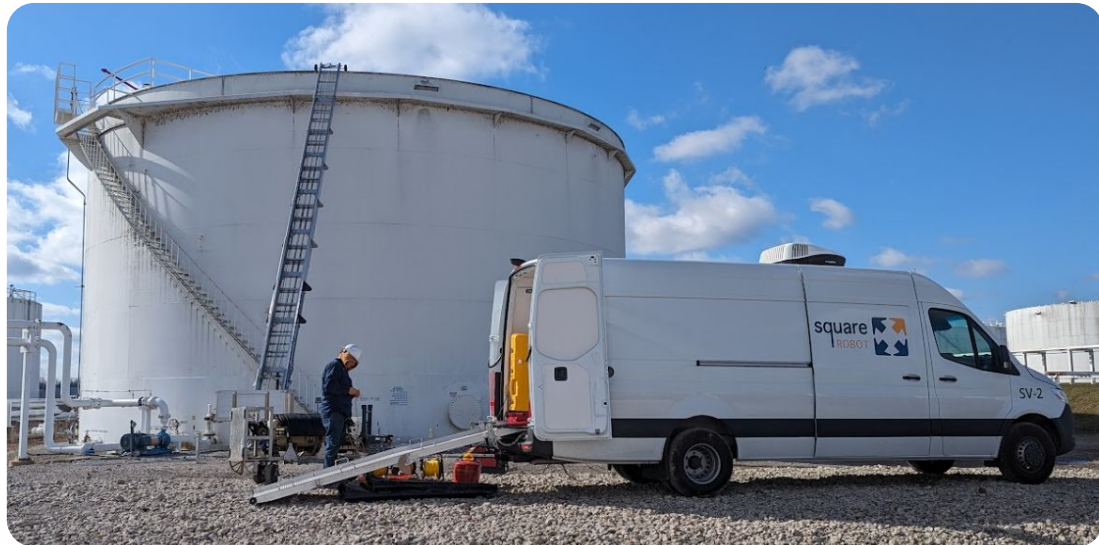
Operations Van

Operations Control Center,
7KW Diesel Power Generator

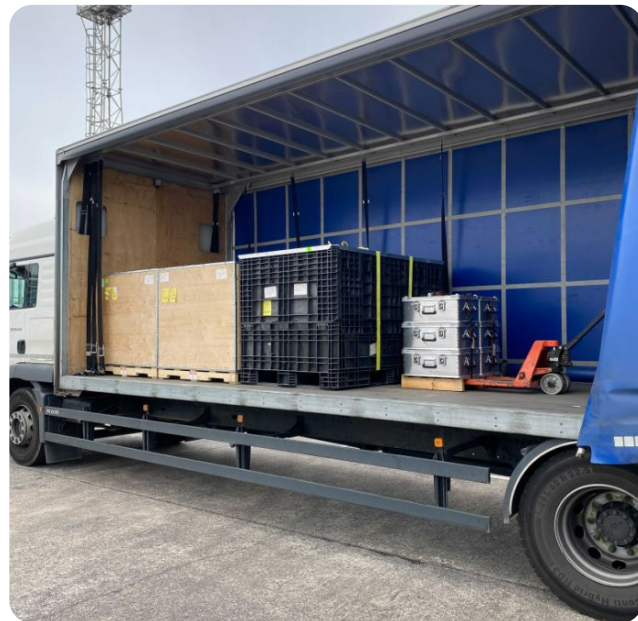
Air Freight

Robot(s), Support Gear, Batteries

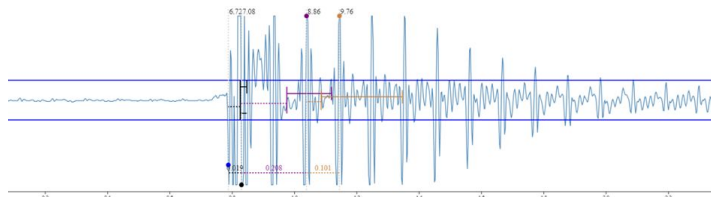
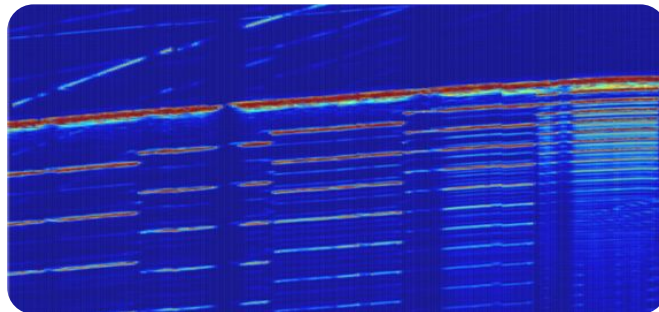
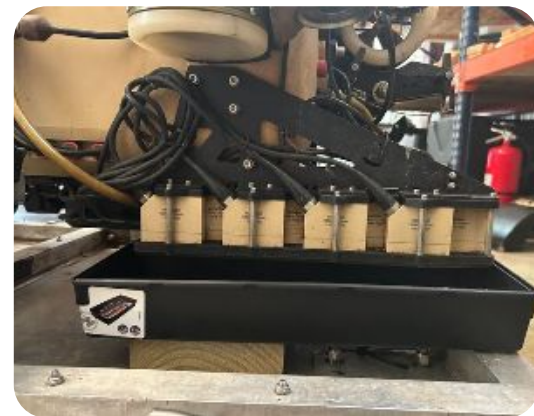
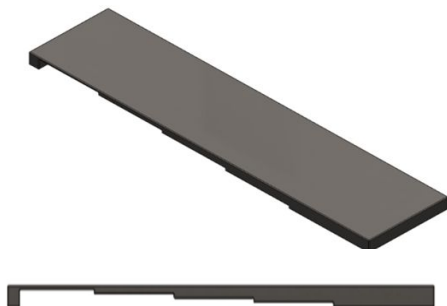
PAUT Calibration/ Function Testing

- Standardization Block is 15-inches (381-mm) in length and 3.5-inches (88.9-mm) in width encompassing all the transducers.
- Stainless steel block and A36 Steel used for the functional test.
- 5 steps measuring with each thickness having a ± 0.004 -inch tolerance.

1. 0.100-inch / 2.54-mm
2. 0.200-inch / 5.08-mm
3. 0.300-inch / 7.62-mm
4. 0.400-inch / 10.16-mm
5. 0.500-inch / 12.70-mm

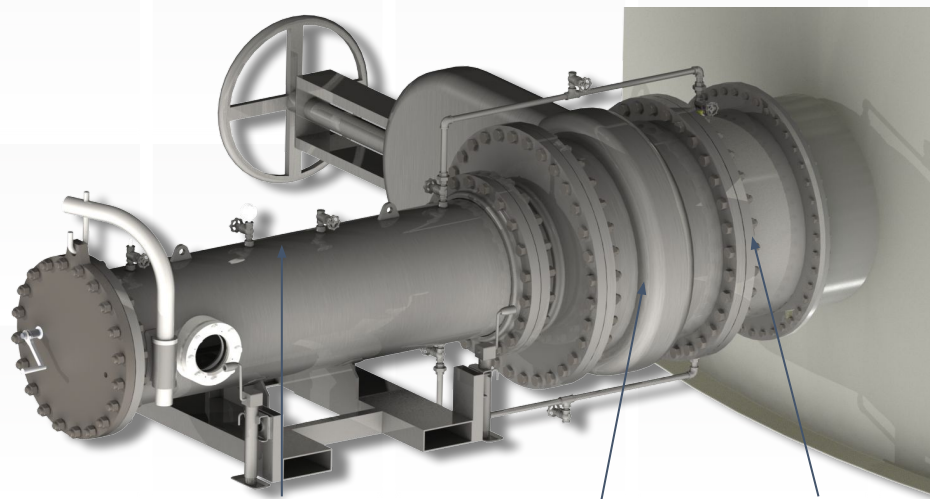
SR-3 Side Launcher System

**Vehicle
Chamber**

**24"
Gate
Valve**

**Manway
Adapter**

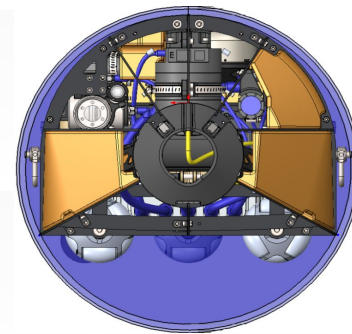
Min.
ID
23.25"

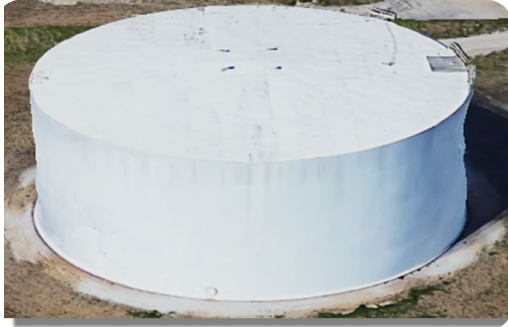
Case Study: 131' Diameter Diesel Tank

Risk Based Inspection:

- Prioritize critical zone
- Maximum floor coverage within allotted 5 day inspection time
- Extended out of service date 15-20 years

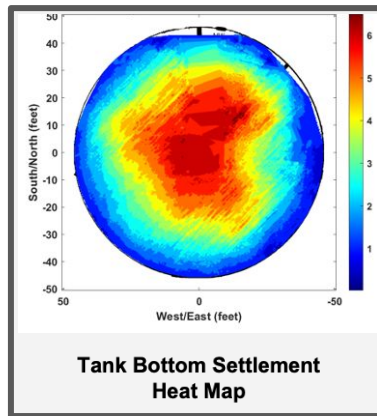
- Inspection Time: 3 DAYS
- UT Tank Bottom Coverage: 78%
- UT Plate Coverage: 29/31 plates
- Confidence Level: High

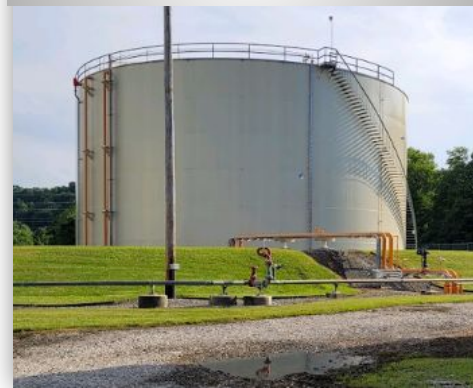
Plate 7D:
Soil side defect,
30.4% wall loss

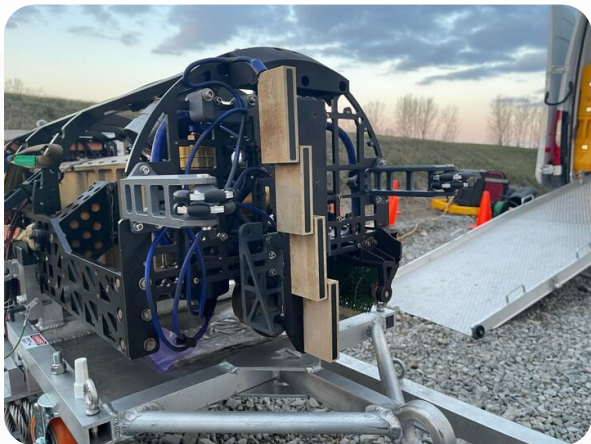
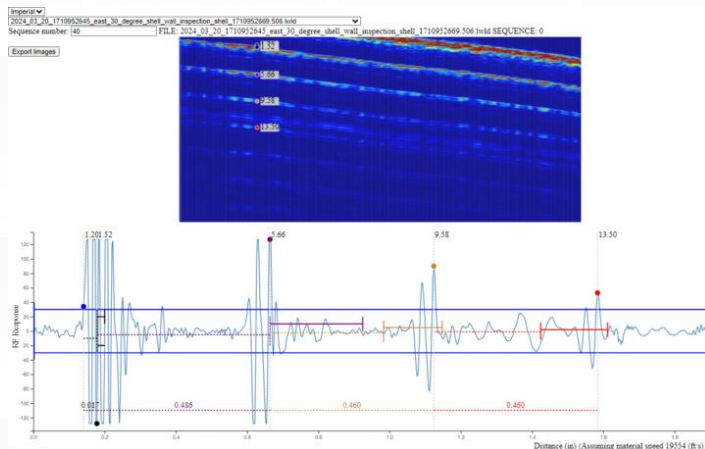
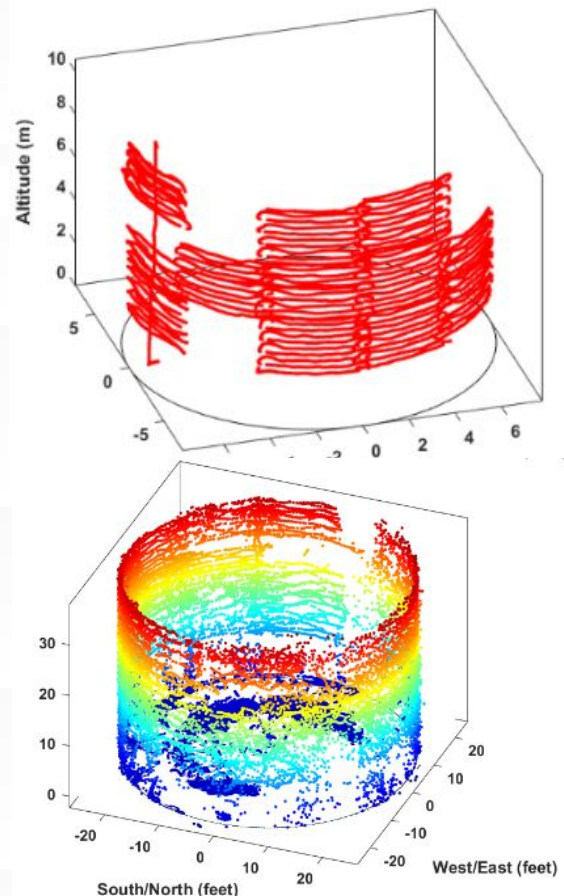
SR-3 Internal Shell PAUT Inspection

- Improved internal shell coverage and access versus external point UT
- Insulated tanks
- Reorient PAUT to face shell
- High quality data and coverage results
- Next step to internal seal inspection with camera - orient camera toward roof seal
