# **In-Service Aboveground Storage Tank Floor Inspection**

## **NDT Payload Validation API-653 Plate Test Plan and Report**

Two NDT sensor payloads, PEC and PAUT, are evaluated against a known plate machined to meet API-653 Annex G Qualification Standards. Results demonstrate each sensor's repeatability across mission data sets. PEC and PAUT results detect similar patterns of corrosion on the test plate. PAUT results were able to repeatedly detect each individual qualification. Thickness measurements generated by the PEC sensor are on average more than 30% greater than the actual thickness. PAUT prove-up results track actual values with an average difference of 3% WT loss. PEC demonstrates an ability to detect defects and is an option for bottom-scanning. PAUT demonstrates an ability to detect and size defects, meeting API-653 Qualification Standards, and is an option for bottom-scanning and prove-up using the robot's survey procedures.

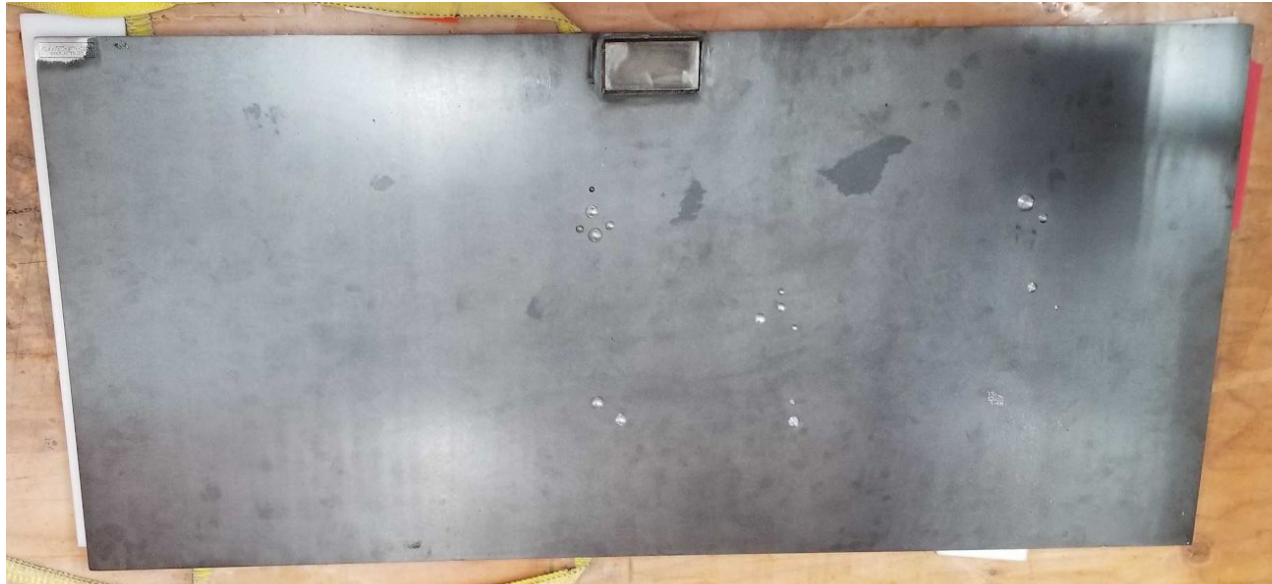
*Figure 4 - API-653 Test Plate (SRPN 02926), Top (Product-Side) View*

A complete mechanical drawing and inspection of the plate is included in the Appendix of this report (see Figures 57-59). Figure 3 provides the high-level defect specifications for the plate. Figures 4 and 5 show the physical plate's top and bottom sides. Note that when viewing the plate from the bottom-side, defect patterns will appear mirrored when comparing the photographs to the mechanical drawings, as the mechanical drawings present the defects from the top-side.

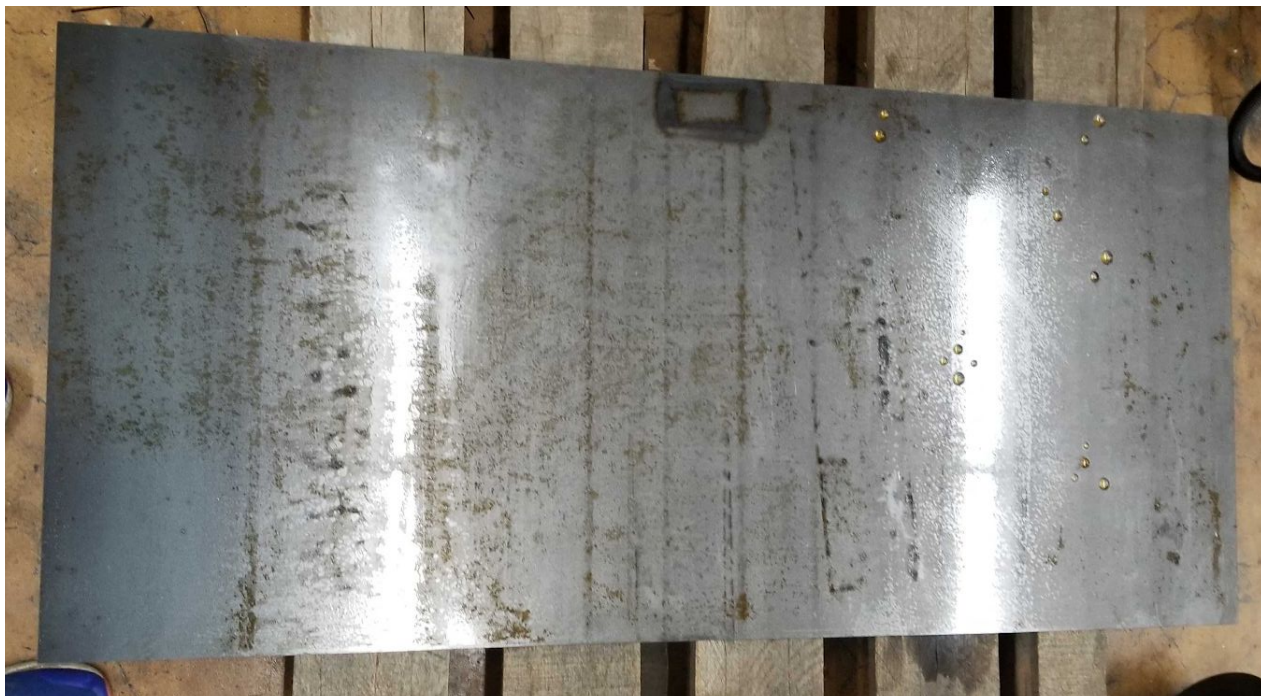
*Figure 5 - API-653 Test Plate (SRPN 02926), Bottom View*

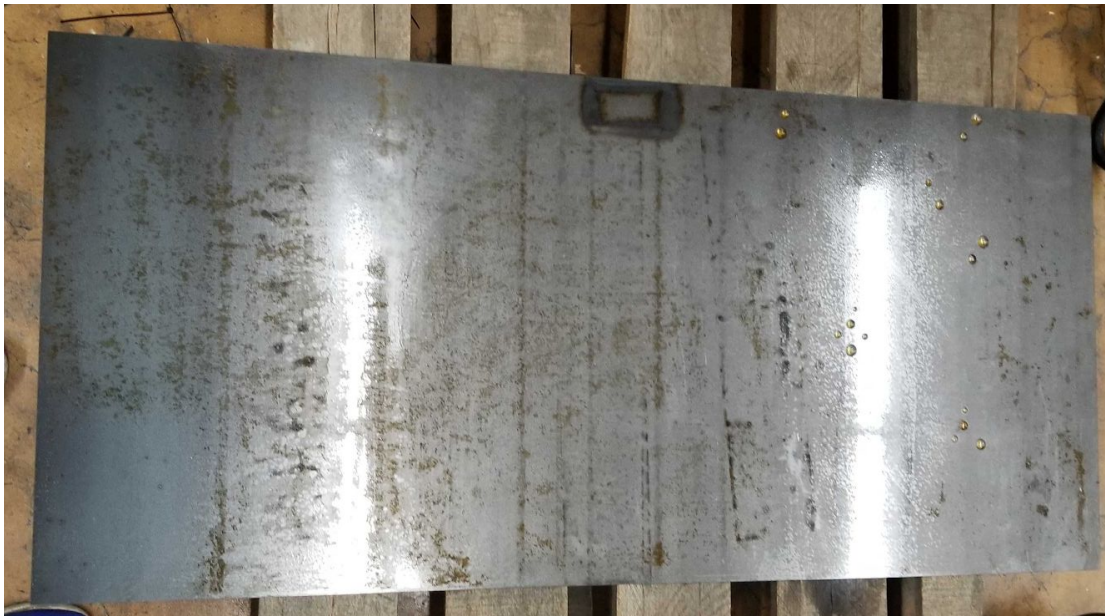
Figure 10 - SRPN 02926 Soil Side View

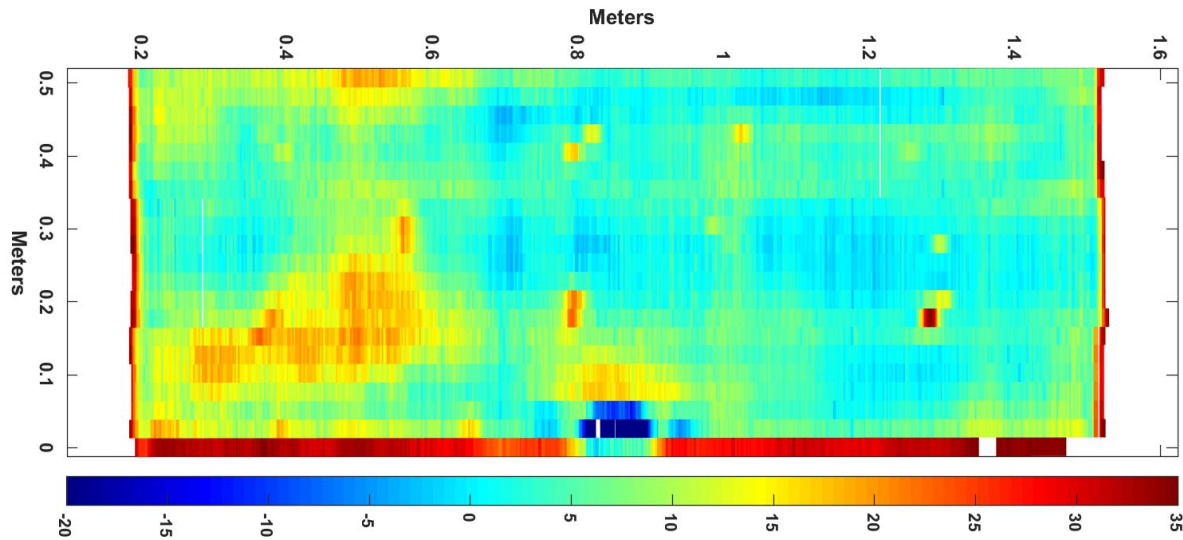
Figure 23 - SRPN 02926 PEC Results, Soil Side Scan, 1/4"x1" Resolution, 0% Overlap

SRPN 02926 PEC missions surveyed the entirety of the plate approached from both the product side and soil side of the plate. Note that Figures 19 through 23 show the plate as surveyed from the soil side of the plate and therefore the results are mirror images of the results from product side inspections. The PEC system consistently detected the presence of the welded lap joint on the plate's edge (See Figure 24), and sized it to be 4" x 2" (0.10 m x 0.05 m). This reflects the actual dimensions of the weldment.

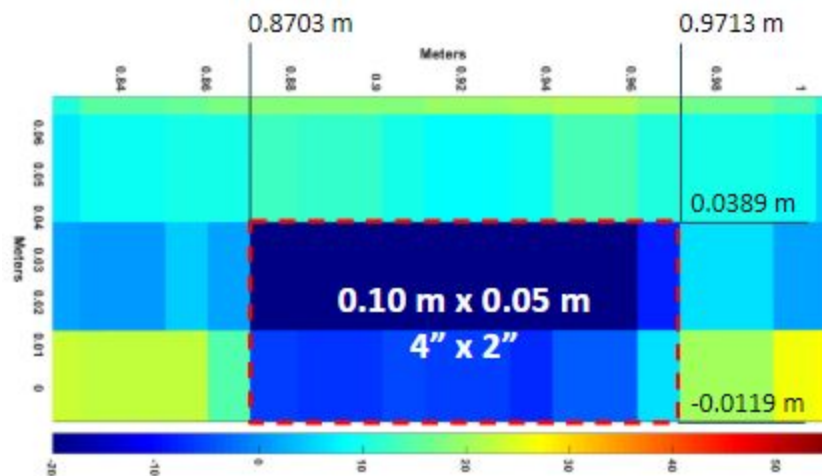
Figure 24 - SRPN 02926 PEC Results, Product Side Scan, 1"x1" Resolution, 50% Overlap, Weldment Sizing

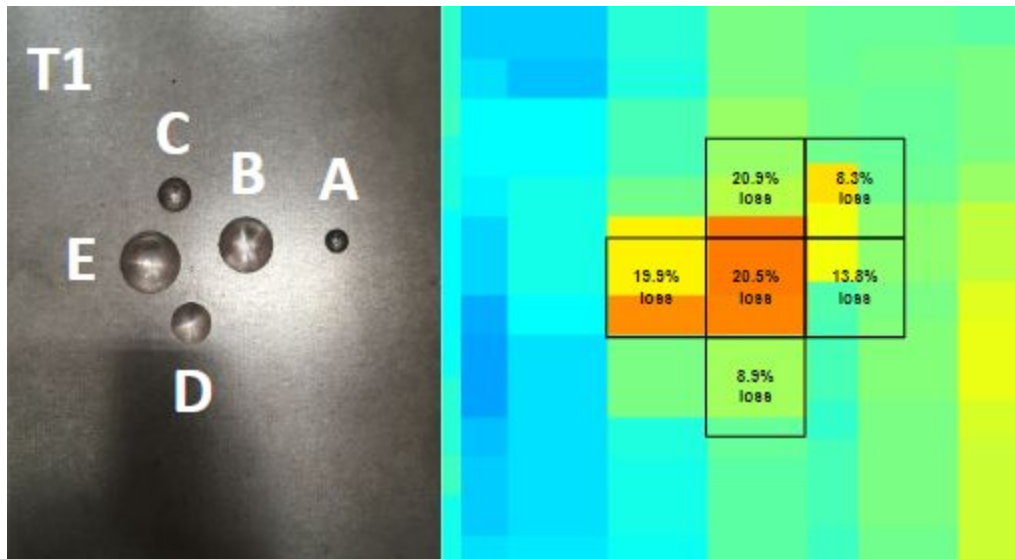
Figure 27 - PEC Results, Product Side Scan, Defect Group T1

The detailed results of the identified qualification defects, detected in the 1"x1" resolution, 50% overlap, product side inspection are summarized below in Table 7 and shown in Figures 27 through

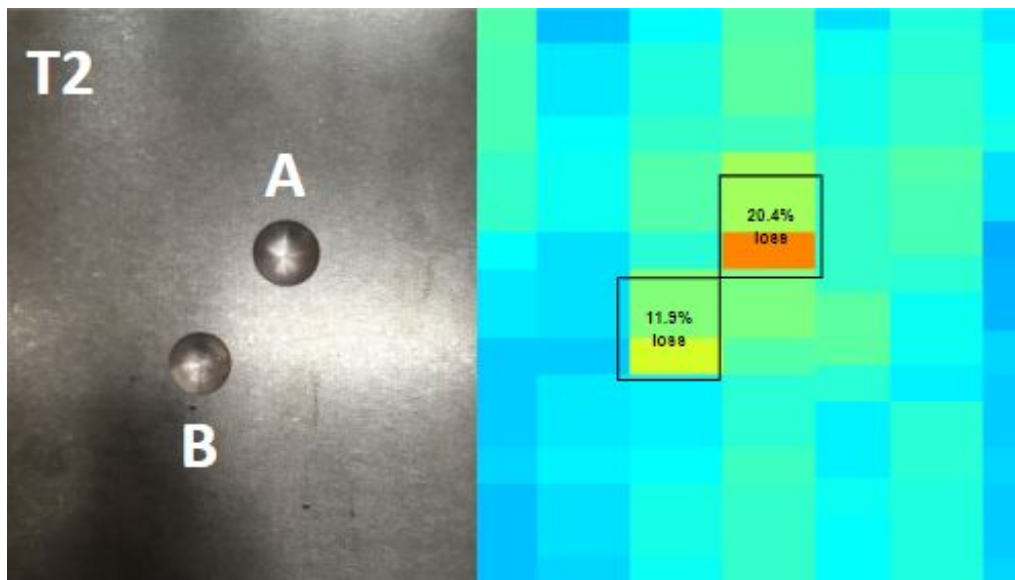
Figure 28 - PEC Results, Product Side Scan, Defect Group T2

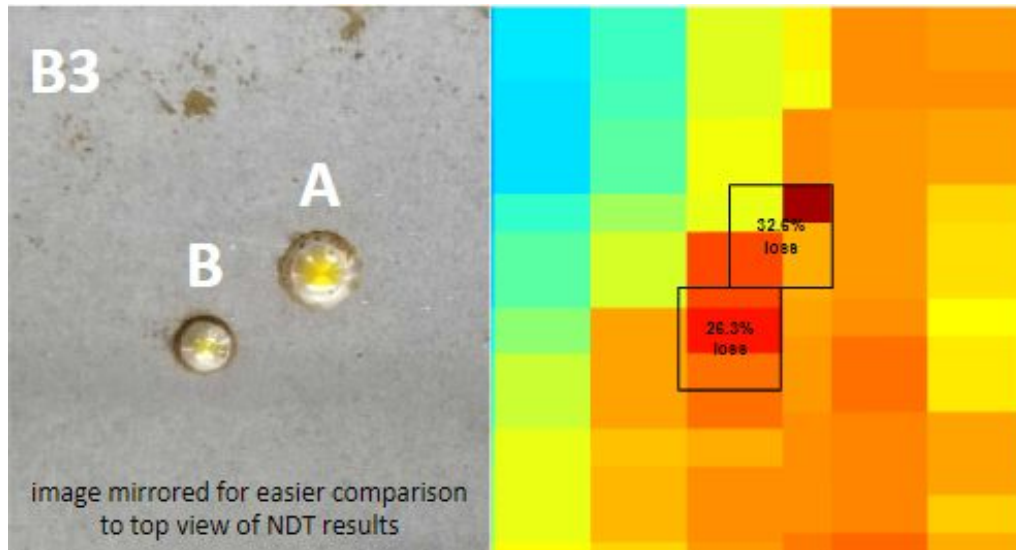
Figure 31 - PEC Results, Product Side Scan, Defect Group B3

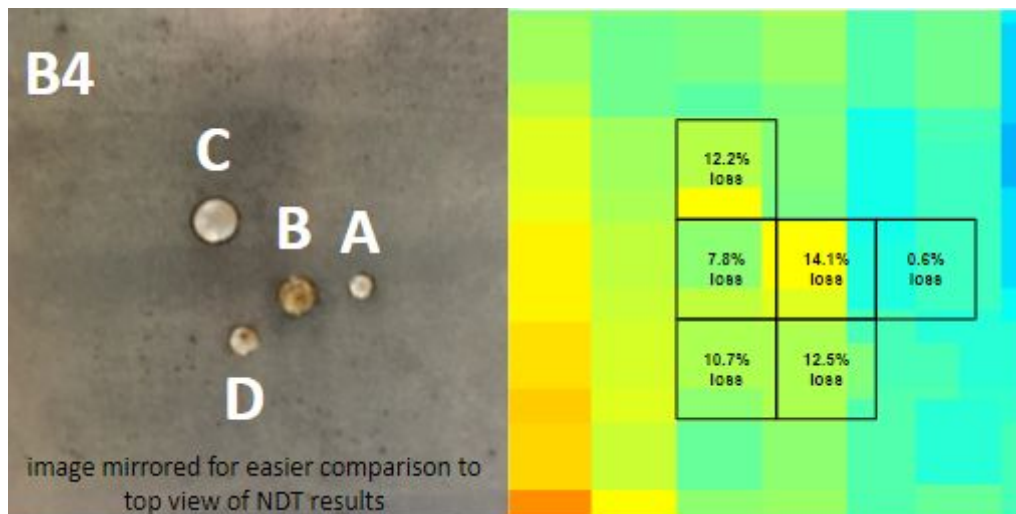
Figure 32 - PEC Results, Product Side Scan, Defect Group B4

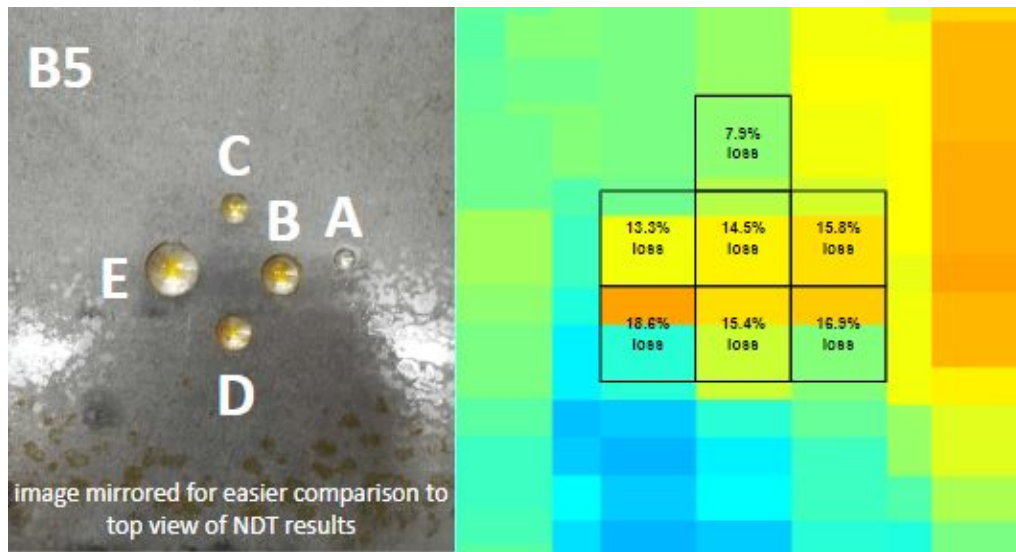
Figure 33 - PEC Results, Product Side Scan, Defect Group B5
